Historical Release Report

**Response to Comments
for
HRR Annual Updates (1997, 1998, 1999)**

Kaiser-Hill Company, L.L.C.

**Response to Comments and Meeting Agreements
for the
Historical Release Report (HRR)
PAC Narratives Submitted for No Further Action in 1997, 1998 and 1999**

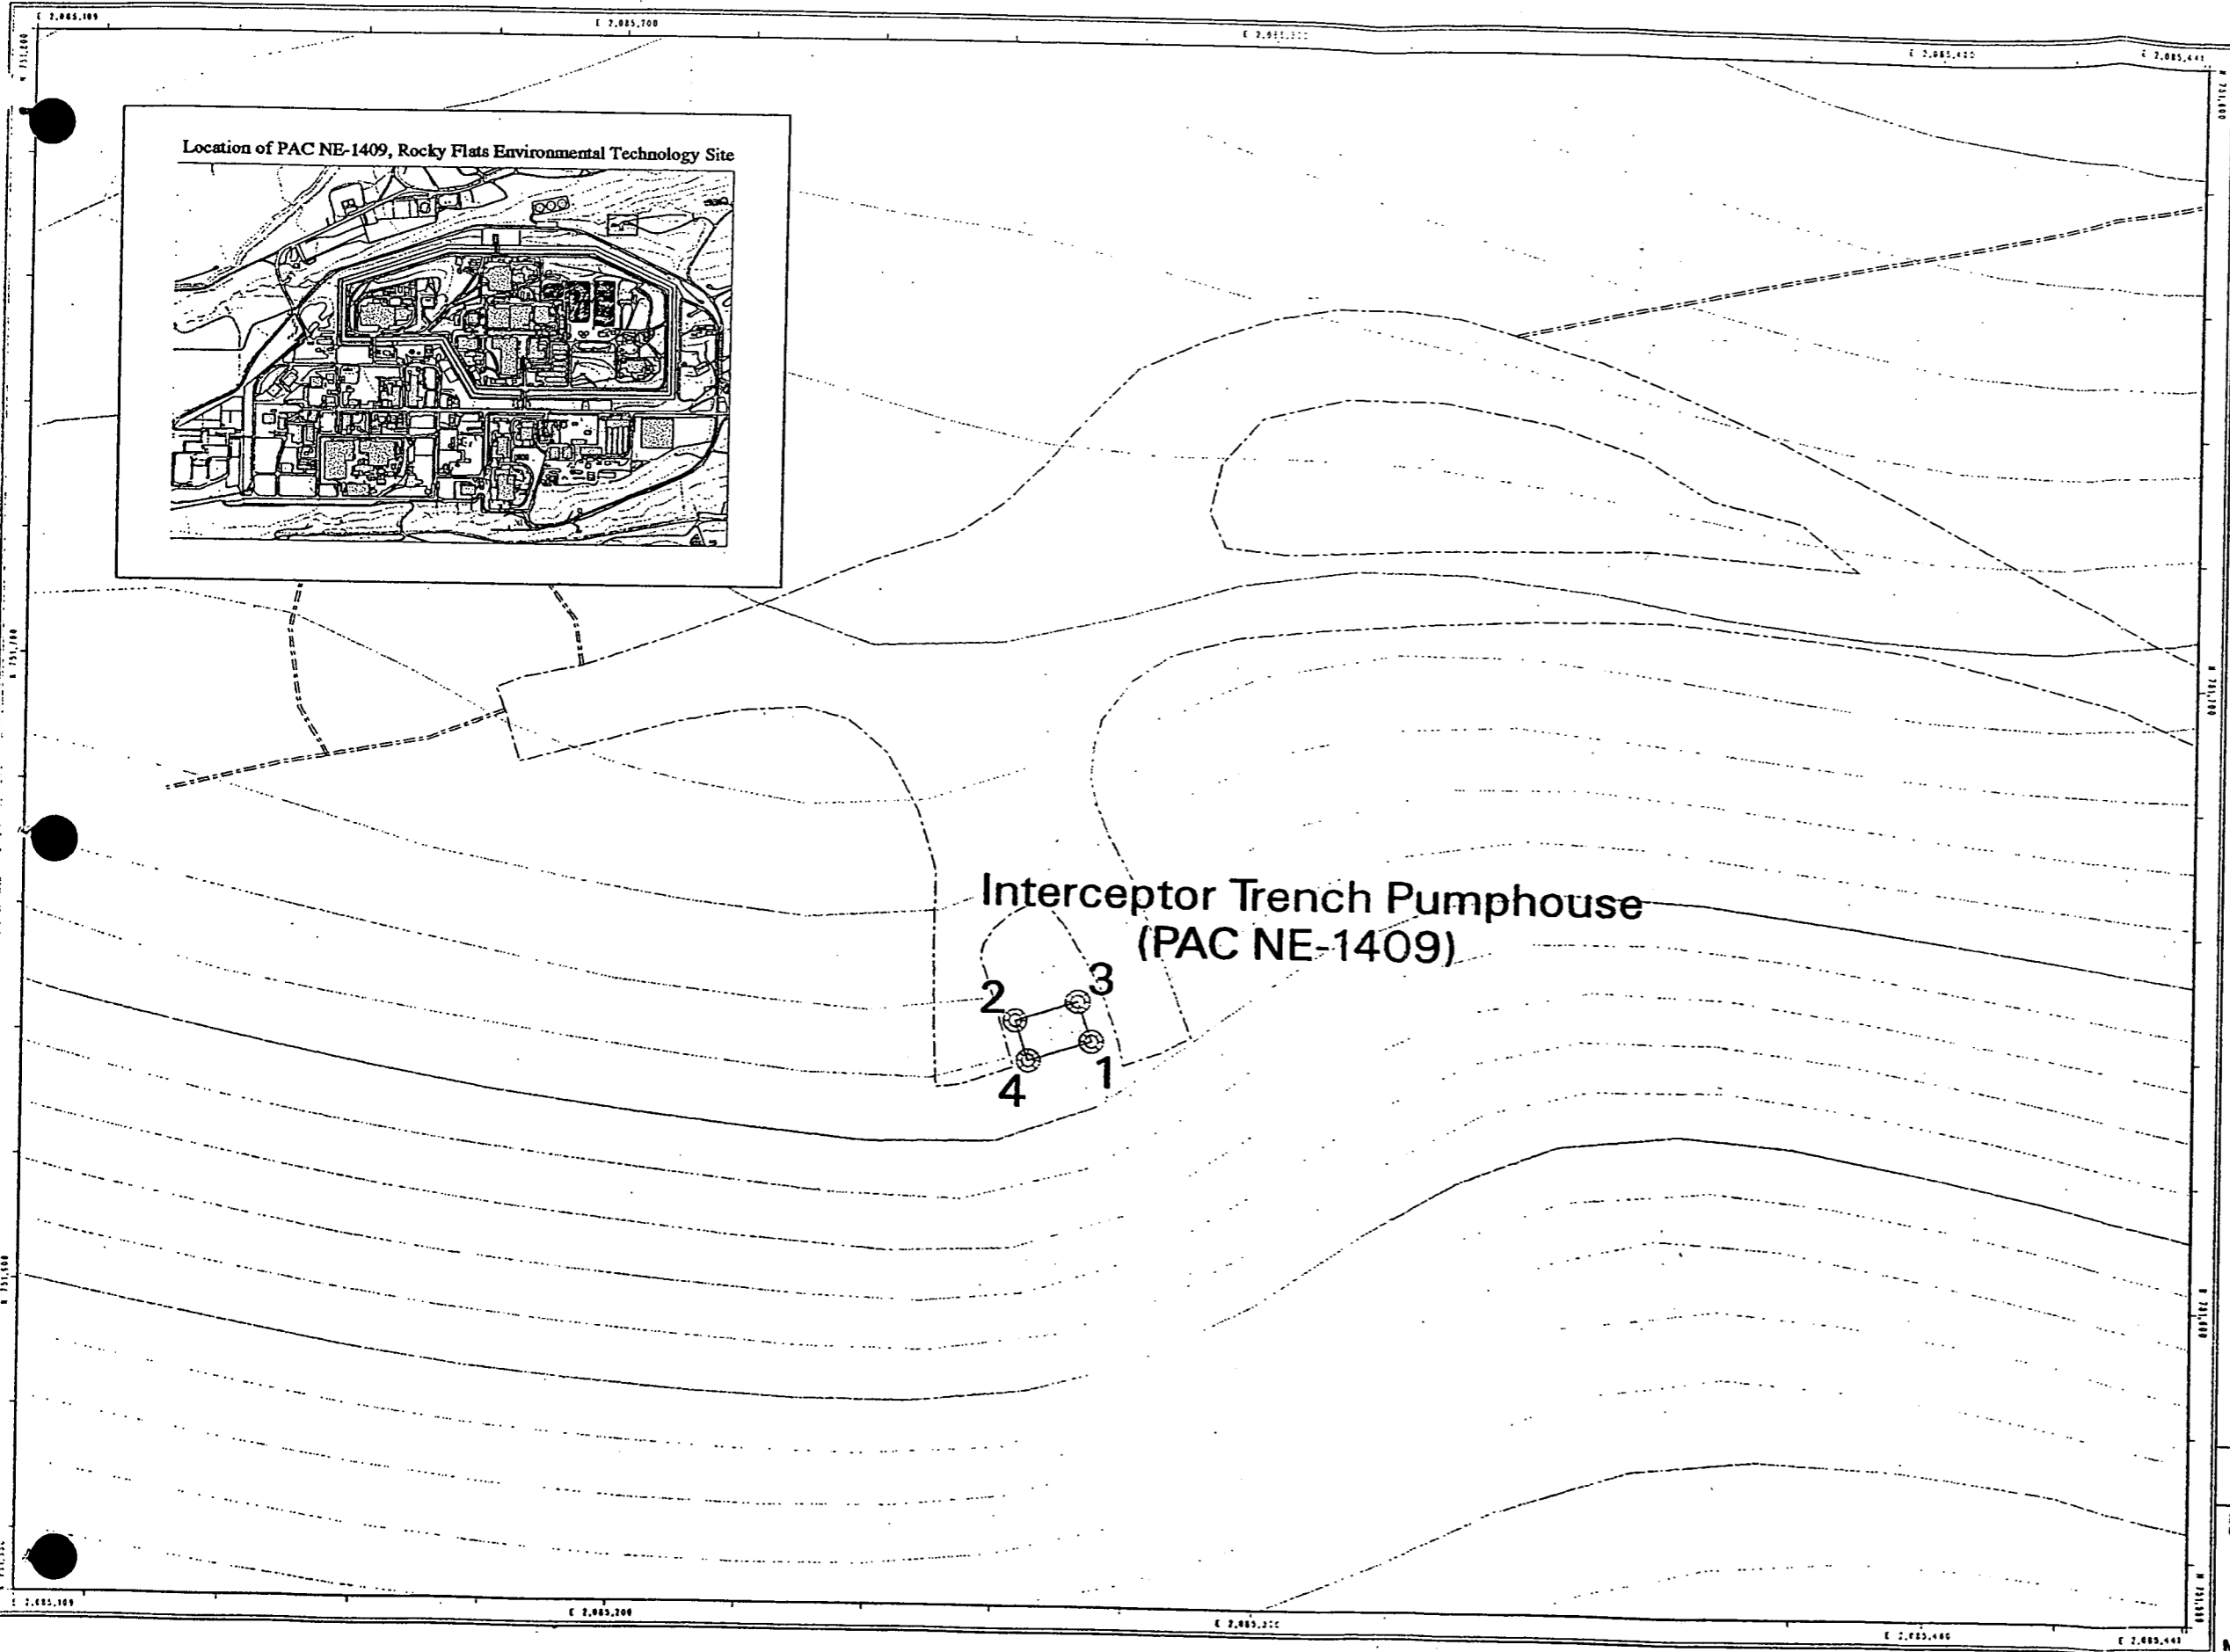
Figure 3.3
Sample Location Map
Potential Areas of Concern
PAC NE-1409

All of the analytical results are below RFCA action levels. Results of the analyses are summarized in Table 3.7 along with the appropriate RFCA action level. All of the analytical results are presented in the Draft No Further Action Justification Document for Incorporation into the Historical Release Report (HRR) for PACs NW-1501, NE-1408, NE-1409, 900-1309, 900-1311, 900-1312, 900-1313 (RMRS, 1999).

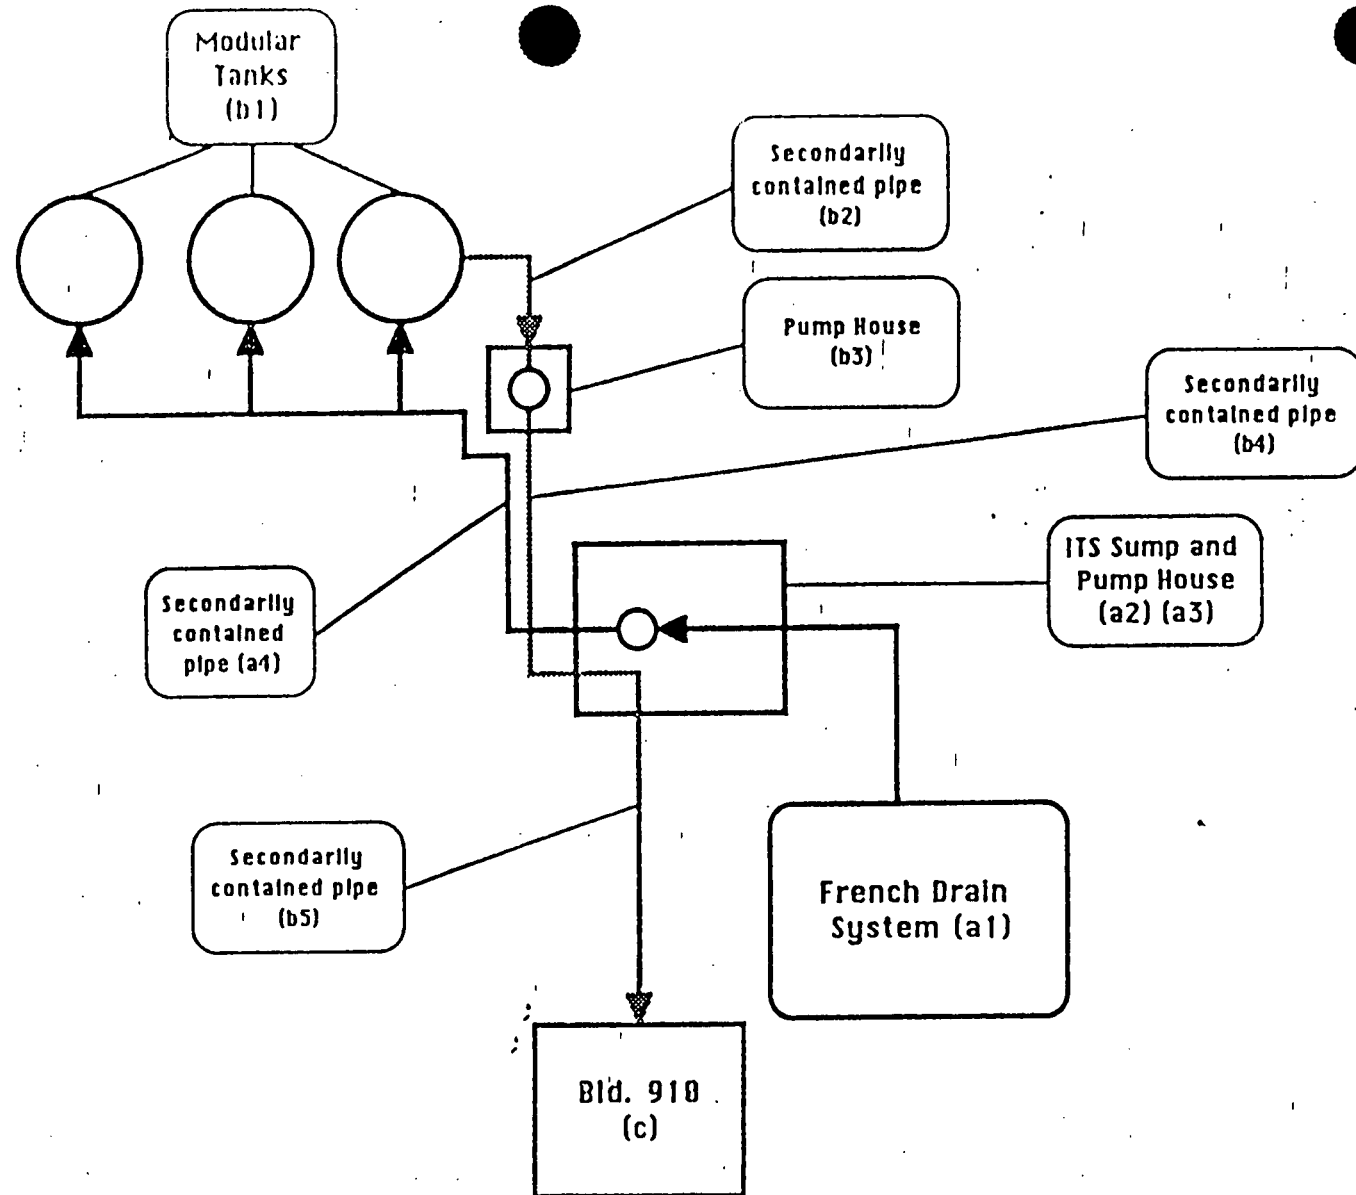
FIGURE 2

Prior to 1:00 p.m. on July 20, 1993, a leak occurred in the primary containment piping (reference Figure 2 - item (b4)) located between the modular tanks and the ITS sump (reference Figure 2 - item a2) which allowed waste to leak into the secondary containment. Due to the location of the leak in the pipeline, the hazardous waste that leaked into the secondary containment overflowed back into the Modular Tank pumphouse (reference Figure 2 - item b3) and also gravity-drained through a failed hose connection on the secondary containment piping (reference Figure 2 - item a2). The failed hose connection is located within the ITS sump. The ITS sump is equipped with an automatic level controls and the material that spilled into the ITS sump was pumped back into the Modular Tanks. The hazardous waste that overflowed into the Modular Tank pumphouse was fully contained in the pumphouse secondary containment. When the liquid level in the pumphouse secondary containment rose, the leak detection system was activated, the local alarm was activated, and the pumps were automatically shut down. The remote alarm via telemetry to Building 374 did not, however, function. Problems had occurred previously and this alarm was not reliable; therefore, it had not been considered operational and compensatory measures were in place to perform daily checks of the local alarm panel. This deficiency had been identified as an open item to be corrected.

As specified in 6 CCR 1007-3, ground water is not a solid waste and the "mixing" and "derived from" rules are not operable in this system. The ITS system, including the French Drain system, are not hazardous waste systems and the surface/ ground water in these systems is not characterized as hazardous waste (reference Figure 2 - item a1). The surface/ ground water stored in the ITS is not characterized as hazardous waste (reference Figure 2 - item a2).

The released material is, however, RCRA F-listed hazardous waste. In accordance with 6 CCR 1007-3, the pumping operation at the ITS sump is considered a waste generation point (reference Figure 2 - item a3). At this point (reference Figure 2 - item a3), the surface/ ground water is recharacterized as RCRA F Listed hazardous waste because the "contained in" rule is operable. The applicable EPA waste codes are F001, F002, F003, F005, F006 F007, and F009.

- 5) In accordance with 6 CCR 1007-3 Part 264.196 (e)(3) - Repair of the affected system: The system will be returned to service as soon as the necessary repairs are completed. The following actions will be completed prior to returning the system to operation:

- Repair the primary transfer line,
 - Repair or modify the portion of the secondary containment of the transfer line (the hose connection) within the ITS sump that

failed and resulted in the leak of hazardous waste from the secondary containment system, and

- Retest the primary line following the repair.

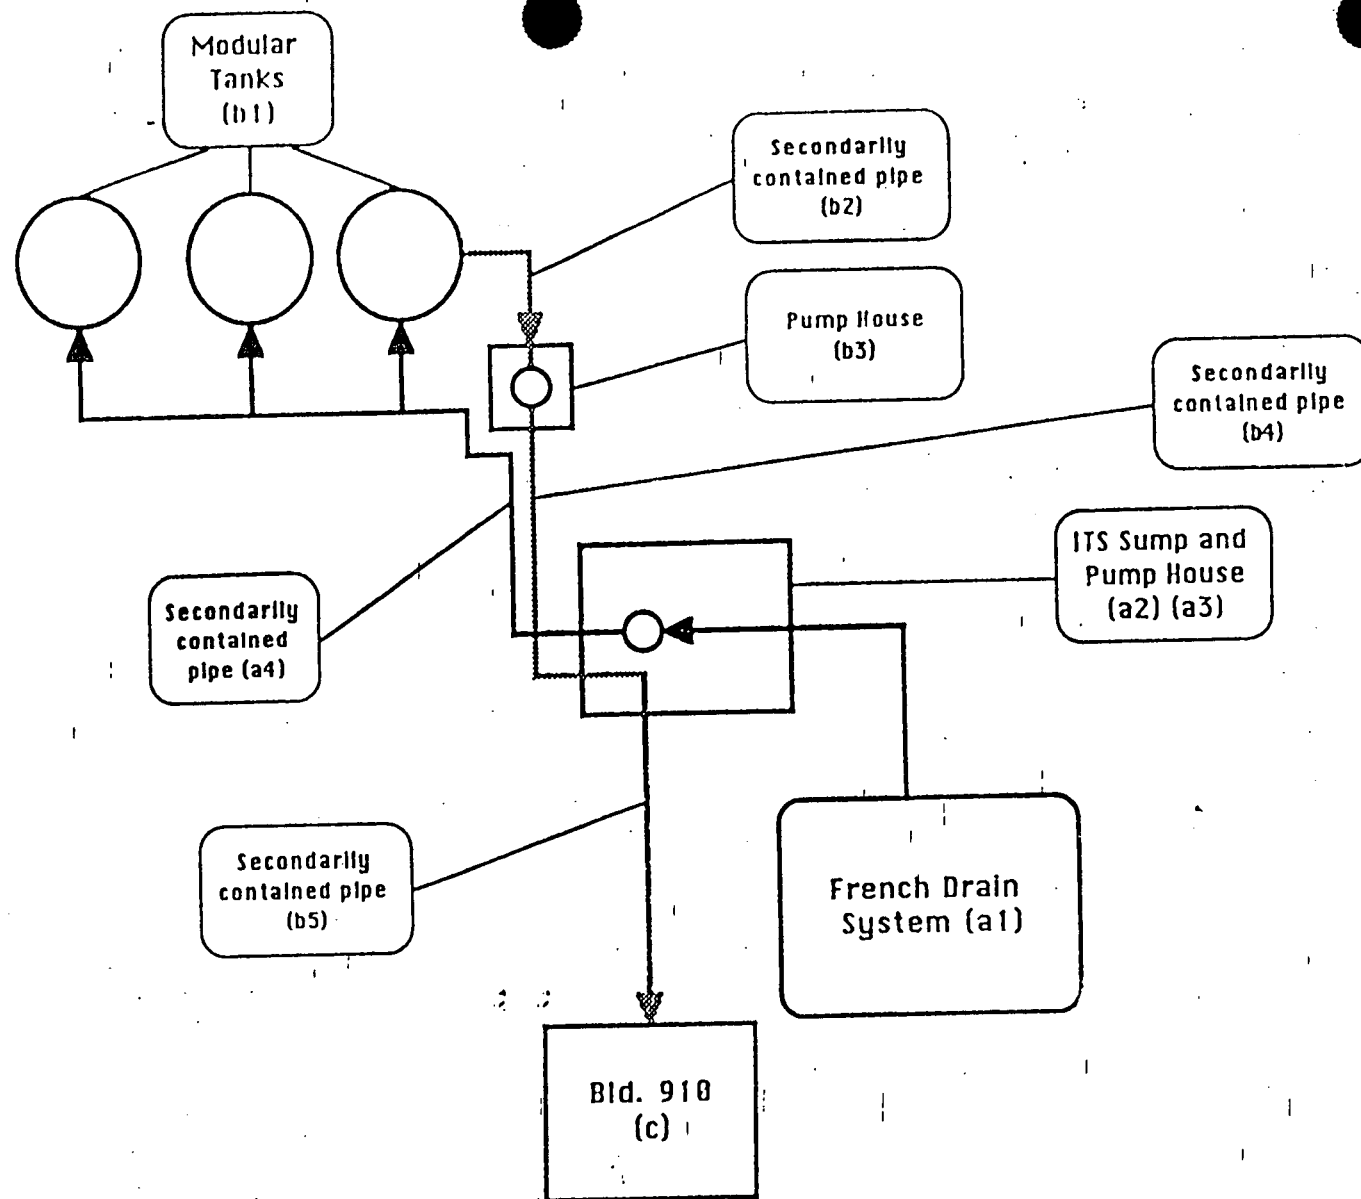
FIGURE 2

- 2) The ITS sump is an underground, unlined, concrete vault that stores the surface and ground water (reference Figure 2 - item a2). The ITS sump is not secondarily contained.
- 3) A small building housing two pumps is located on top of the sump (reference Figure 2 - item a3). The sump pumps transfer the surface and ground water collected in the sump-several hundred feet to the modular storage tanks. In accordance with 6 CCR 1007-3, the pumping operation is considered a waste generation point. At this point, the generated waste (pumped surface/ ground water) is characterized as RCRA hazardous waste.

- 4) The waste is pumped through 2-inch secondarily contained, buried pipe (reference Figure 2 - items b4 and b5) several hundred feet from the modular tank pumphouse through the ITS sump (reference Figure 2 - item a2) and to the Building 910 treatment system (reference Figure 2 - item c). The primary containment pipe is continuous and does not open to or stop at the ITS sump. The secondary containment piping is divided into two sections to allow segregation and identification if a leak should occur. The partition between the two sections of secondary containment is located within the ITS sump. The automatic leak detection system for these two sections of secondary containment was not operational; therefore, daily inspections were being conducted until the automatic system could be made operational. The pipeline

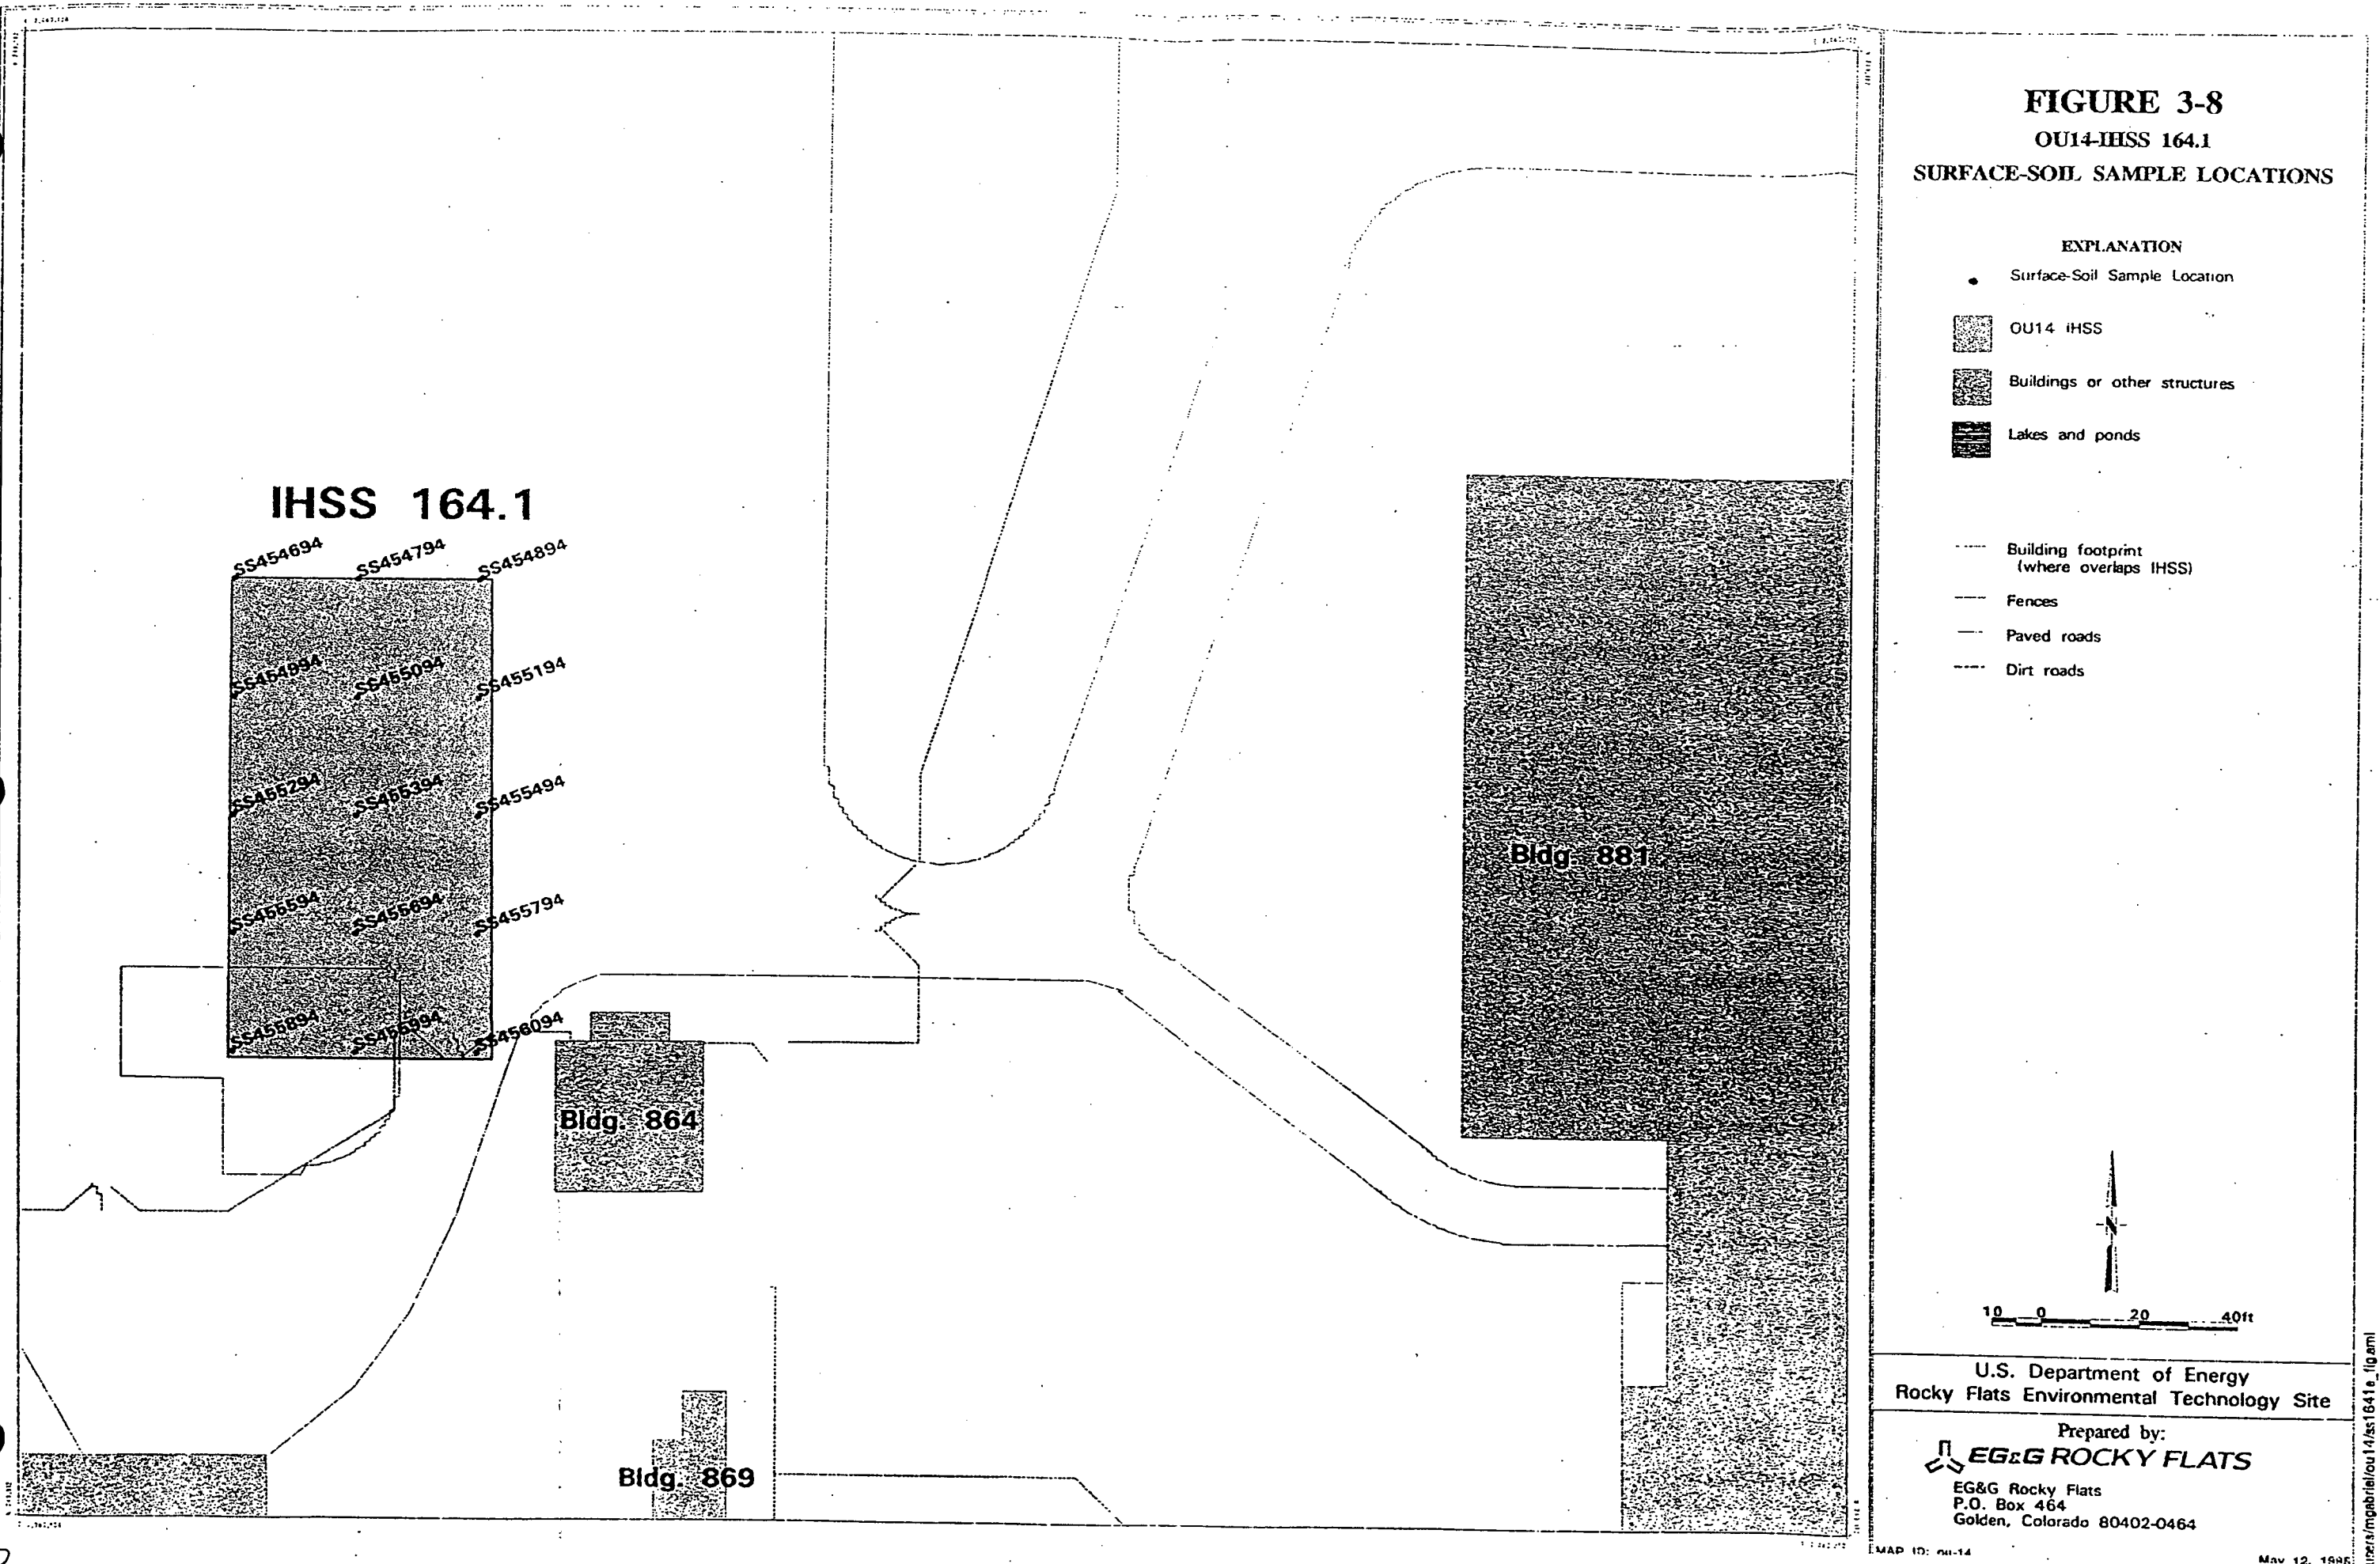
FIGURE 3-8
OU14-IHSS 164.1
SURFACE-SOIL SAMPLE LOCATIONS

No documentation was found which detailed the fate of the constituents released to the environment. This IHSS was studied according to the IAG schedule for Operable Unit 14. As documented in the Operable Unit 14 Data Summary Report (DOE, 1995), fifteen surficial soil samples were collected (Figure 3-8) and analyzed for radionuclides within IHSS 164.1 (PAC 600-164.1). The isotopic analysis presented in Table 1-1 show that soils for this area are consistent with background activities and that potentially contaminated concrete was effectively cleaned up.
